#### MT 35/US 93 Truck Study

#### **Focus Group Meeting**

November 19, 2008 Kalispell, Montana

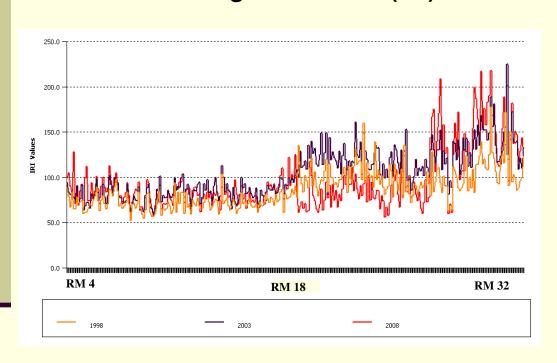
#### International Roughness Index (IRI) on MT 35 in 1998, 2003, and 2008

- Between 1998 and 2008, the pavement from RM 4 to RM 18 deteriorated at a relatively slow rate
- The pavement from RM 18 to RM 26 deteriorated rapidly between 1998 and 2003, and improved in 2008 due to an overlay in 2005
- The pavement between RM 26 and RM 32 is also deteriorating rapidly and needs treatment

Conclusion: MT 35 is structurally capable of carrying heavy truck traffic. However, frequent short-term maintenance fixes are necessary pending major rehabilitation or construction
